HLCD Pty Ltd

Hobsons Bay Heritage Referral

Date	7 July 2025
Property	Williamstown Surf Life Saving Club (WSLSC)
Application No.	PA250139
Proposal	Partial demolition, buildings and works associated with the re-development of the WSLSC
Heritage Status	Contributory to Esplanade Foreshore Heritage Precinct (HO5)
Planner	s 33

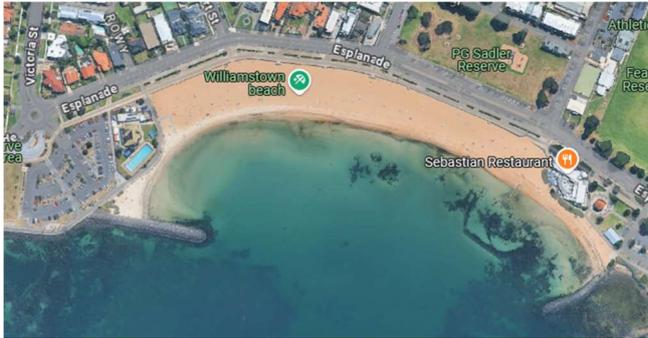
Fig 1: The WSLSC is at the western end of the sweep of sand of Williamstown Beach while the other contributory buildings, comprising the former Williamstown Dressing Pavilion, former Band Rotunda and shelter shed, are at the eastern end.

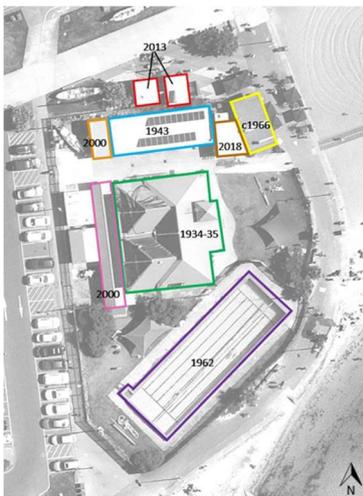
Fig 2: The clubhouse is identified in green as dating from 1934-35. Source: HIS, p9.

The chronology of the buildings on the WSLSC site is shown in the Heritage Impact Statement (HIS) with the clubhouse dating from 1934-35 (refer to fig 2). It is an example of an architect designed Interwar building which is substantially intact. The whole of the 1935 clubhouse remains clearly legible on the site. It was built to the design of architect J W Parry and the drawings are held by HBCC and reproduced in the HIS pp3-4.

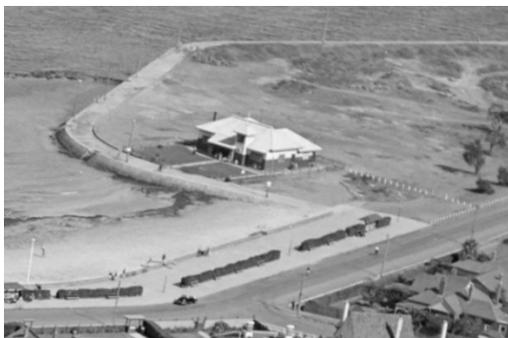
Fig 3: A late 1930s aerial photograph by Charles Daniel Pratt soon after construction of the WSLSC. (<http://handle.slv.vic.gov.au/10381/165226>)

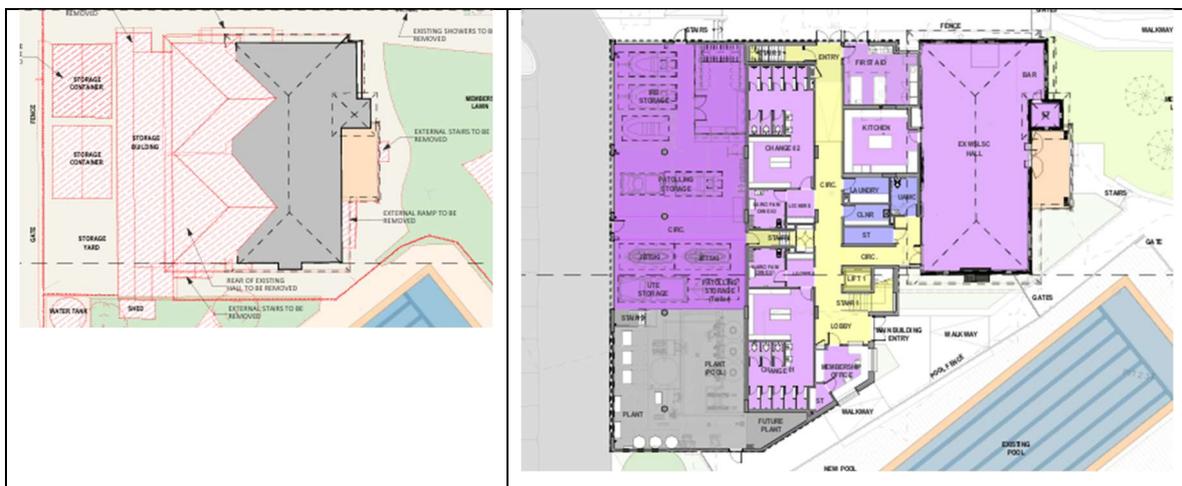
Fig 4: A comparison of the proposed existing roof form with the two western hips in red to be demolished (left) and the retained part with its smaller altered form on the right. The extent of demolished fabric of primary significance is very high.

The partial demolition and change in form to the 1935 clubhouse is contrary to heritage policy and guidelines. It involves demolition of the western part of the clubhouse including removal of its two hipped roofs and interior service spaces. The whole of the 1935 building is of primary significance so this demolition involves the removal of fabric of primary significance.

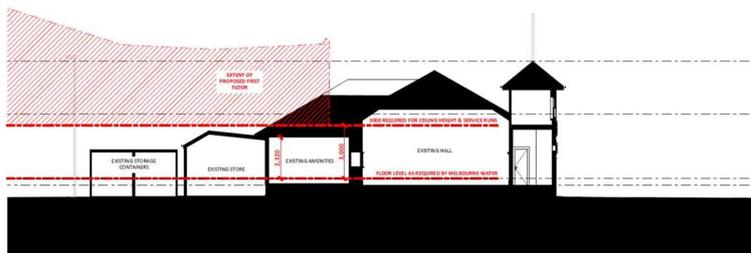
Fig 5: Diagram of floor levels and ceiling heights. Source: HIS p48

Figure 59. Existing section with the 'floor level as required by Melbourne Water' indicated by the dashed red line at bottom, and '3000 required for ceiling height & service runs' indicated by dashed red line at top of building (Source: A401, Rev 01, dated 14/02/2025, Canvas Projects, received via email 27 February 2025)

The HIS states that Melbourne Water advised that the floor level for the clubhouse be raised by 400mm and the consultant team chose not to apply this to the hall to protect the existing space. The HIS argues that it would be applied to the service areas and this rise, in conjunction with the comparatively lower ceiling height in this area, makes these rooms unusable. The diagram below shows that a height of 2320 would be achieved and the HIS states that a height of 3000 is needed.

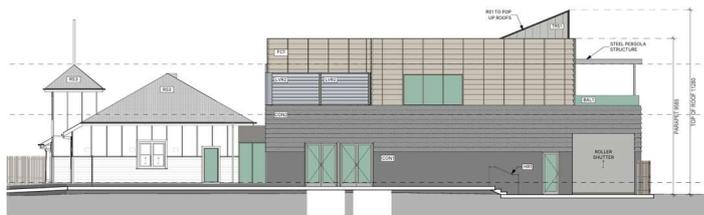
Fig 6: North elevation showing the proximity and scale of the addition to the retained heritage fabric.

The height and mass of the proposed addition to the rear of the hall makes it visually dominant compared to the heritage building. It is a much larger floor area and extends well to the south of the clubhouse with a two storey form. The top of the roof of the clubhouse tower is just over 7 metres tall with the roof ridge and the hipped ends of the clubhouse well below this. Although the new structure is only two storeys, it has a parapet roof form at over 9.5 metres and sawtooth roofs at over 11 metres. The sawtooth roofs are clad in polycarbonate so will be lit up at night when lights are on inside.

The upper floor of the new addition is only separated from the heritage hall by a box gutter. The impact of the taller and wider mass will be substantial on the east elevation facing the beach. However an east elevation of the clubhouse with the addition has not been provided. Drawing TP 313 shows the addition without the heritage building and TP 311 is an elevation of the clubhouse with only part of the addition behind it. No sight line diagrams have been provided.
